17508

17509, 17510, 17511

CURVED TILE ROOF HOOK FOR SIDE MOUNT RAILS

Subject: Uplift, Compressive Load, and Lateral Load Test of QS #17508 (Kit #17511) 90° Non-Adjustable Spanish Tile Roof Hook

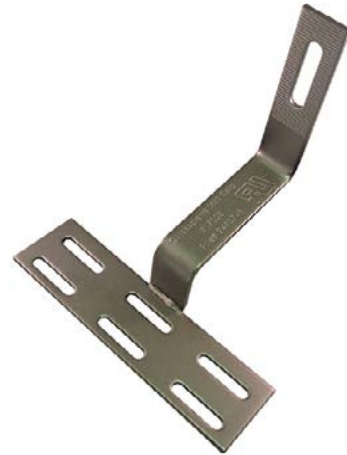
Letter	Description	Size/Length
A	Mounting Screw Slots	7.50mm x 37mm
B	Rail Slot Size	10mm x 46mm
C	Length of Roof Hook	151mm
D	Bottom End to Top End	165mm
E	Thickness	5mm

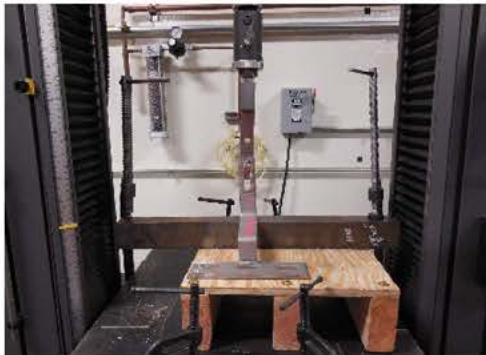
Photo 1: Tensile Test Setup

A total of two tests were conducted for tensile load (uplift) capacity on an Instron Universal Test Machine (UTM). The test samples were rigidly attached to the test machine using clamps and a tensile load was applied to the roof hook. The tensile load was applied at a constant rate of 0.09 in./min. without shock until failure. The load and displacement at failure were recorded and the failure mode was documented in photos. The average tensile load of the 90° Non-Adjustable Spanish Tile Roof Hook attached to 2"x4" using the #14 x 3" Solar Mounting screws was 1906 lbf. Additional details and photographs are supplied on page 3.

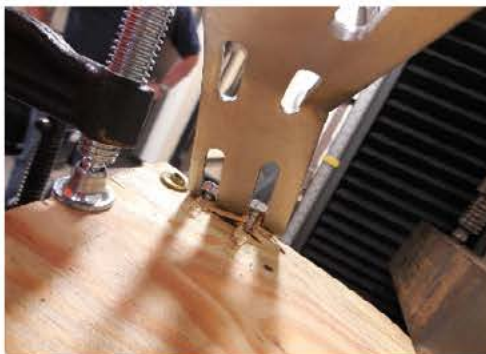
Photo 3: Closeup of Fastener Pullout

CLIENT		CLIENT PROJECT REF. NO.		CLIENT ORDER NO.	
SolarRoofHook		17508, 17509, 17510, 17511		Per S.A.	
SAMPLE DESCRIPTION			ROOF HOOK ID		PRODUCT KIT ID
90° Non-Adjustable Tile Roof Hook			17508, 17509		17510, 17511
MATERIAL SUBMITTED BY		PNL PROJECT NO.	S.O. NO.	PNL LAB NO.	REPORT DATE
Client		26-170169	001	ML827502	04/05/2017
TEST SPECIFICATIONS & EQUIPMENT INFORMATION					
TEMPERATURE:		73° ± 3°F		HUMIDITY:	
EQUIPMENT MODEL:		Instron 5985		SERIAL NO:	
LOAD CELL:		50 kN (11,240 lbf)		SERIAL NO:	
TEST SPEED:		0.09 in./min.		FASTENER TYPE:	
FASTENER LOCATION:		Fasteners (Qty 2) installed in furthest slot point and secured to 2 x 4 running underneath plywood.			
TENSILE LOAD (UPLIFT) TEST DATA					
NO.	MAXIMUM LOAD (lbf)	DISPLACEMENT AT LOAD (in.)	OBSERVATIONS		
1	1700.7	5.762	Fastener pullout and permanent deformation failure.		
2	2110.2	5.340	Fastener pullout and permanent deformation failure.		
AVG.	1905.5	5.551

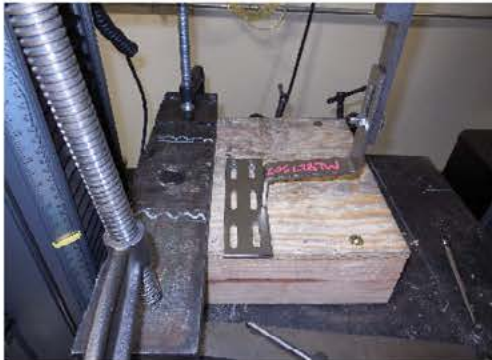
Photo 5: Compression Test Setup

A total of two tests were conducted for compressive load capacity on a UTM. The test samples were rigidly attached to the test machine using clamps and a compressive load was applied to the roof hook. The compressive load was applied at a constant rate of 0.09 in./min. without shock until the roof hook came into contact with the plywood base. The load and displacement at contact were

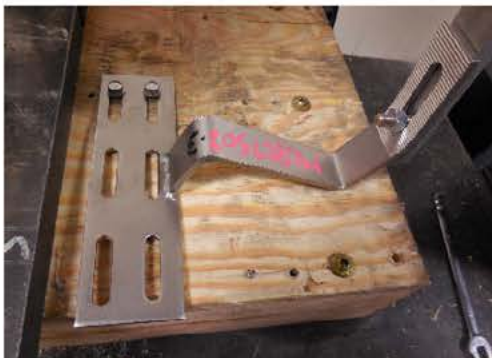
Photo 7: Hook Contact with Plywood

recorded and the failure mode was documented in photos. The average compressive load of the 90° Non-Adjustable Spanish Tile Roof Hook attached to 2"x4" using the #14 x 3" Solar Mounting screws was 255 lbf. Additional details and photographs are supplied on page 4.

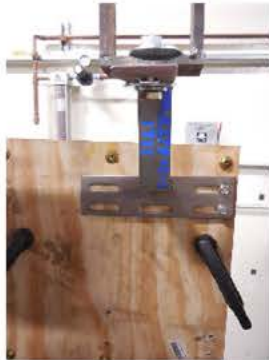
Photo 9: Shear Test Setup

A total of two tests were conducted for shear load (lateral load) capacity on a UTM. The test samples were rigidly attached to the test machine using clamps so that a compressive load could be applied to the roof hook in a direction parallel to the 2"x4" rafters. The shear load was applied at a constant rate of 0.09 in./min. without shock until the roof hook until failure. The load and displacement at tact were recorded and the failure mode was documented in photos. The average compressive load of the 90° Non-Adjustable Spanish Tile Roof Hook attached to 2"x4" using the #14 x 3" Solar Mounting screws was 354 lbf. Additional details and photographs are supplied on page 5.

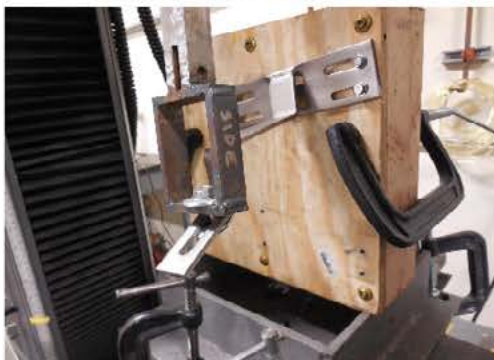
Photo 11: Deformation of Hook at Weld

CLIENT		CLIENT PROJECT REF. NO.		CLIENT ORDER NO.	
SolarRoofHook		17508, 17509, 17510, 17511		Per S.A.	
SAMPLE DESCRIPTION			ROOF HOOK ID		PRODUCT KIT ID
90° Non-Adjustable Tile Roof Hook			17508, 17509		17510, 17511
MATERIAL SUBMITTED BY		PNL PROJECT NO.	S.O. NO.	PNL LAB NO.	REPORT DATE
Client		26-170169	001	ML827502	04/05/2017
TEST SPECIFICATIONS & EQUIPMENT INFORMATION					
TEMPERATURE:		73° ± 3°F		HUMIDITY:	
EQUIPMENT MODEL:		Instron 5985		SERIAL NO:	
LOAD CELL:		10 kN (2,248 lbf)		SERIAL NO:	
TEST SPEED:		0.09 in./min.		FASTENER TYPE:	
FASTENER LOCATION:		Fasteners (Qty 2) installed in furthest slot point and secured to 2 x 4 running underneath plywood.			
SHEAR LOAD TEST DATA					
NO.	MAXIMUM LOAD (lbf)	DISPLACEMENT AT LOAD (in.)	OBSERVATIONS		
5	348.7	10.237	Permanent deformation of rail attachment section.		
6	359.1	10.435	Permanent deformation of rail attachment section.		
AVG.	353.9	10.336

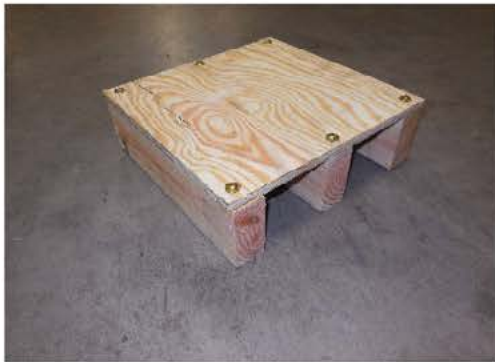
Photo 13: Test Mockup Base Assembly

The base for the test assemblies was made from three 12 in. long Douglas Fir 2"x4"s screwed to 12 mm Birch plywood using 5/16" x 3-1/8" RSS Rugged Structural screws. The Roof Hooks were then attached using two of the Client provided #14 x 3" Solar Mounting Screws. On roof hooks that had multiple mounting screw slots, the screws were set at the furthest end of the furthest slot from the 90° section of the roof hook. The mounting screws were screwed through the plywood and into a 2"x4" underneath. On adjustable roof hooks, the 90° roof hook attachment was connected at one extreme end and the mounting screws were attached in screw slots at the opposite end.

Each roof hook was attached to a Douglas Fir 2"x4" using two #14 x 3" Solar Mounting Screws. The 2"x4" rafter and plywood test fixtures were assembled in our laboratory by using 5/16" x 3-1/8" RSS Rugged Structural screws to connect three 12 in. long 2"x4" douglas fir rafters to the 12 mm Birch plywood. Each 2"x4" rafter was connected to the plywood using two screws at each end of the 12 in. long 2"x4" (See Page 6 for photos and details).

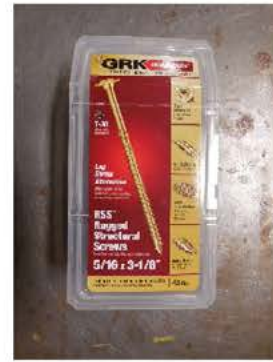
Photo 14: Fasteners for Plywood to 2x4: 5/16 x 3-1/8" RSS Rugged Structural Screws
